**Technical Investigation:** 6P & T4 abutment check with aftermarket D0731 pads.

11 June 2019

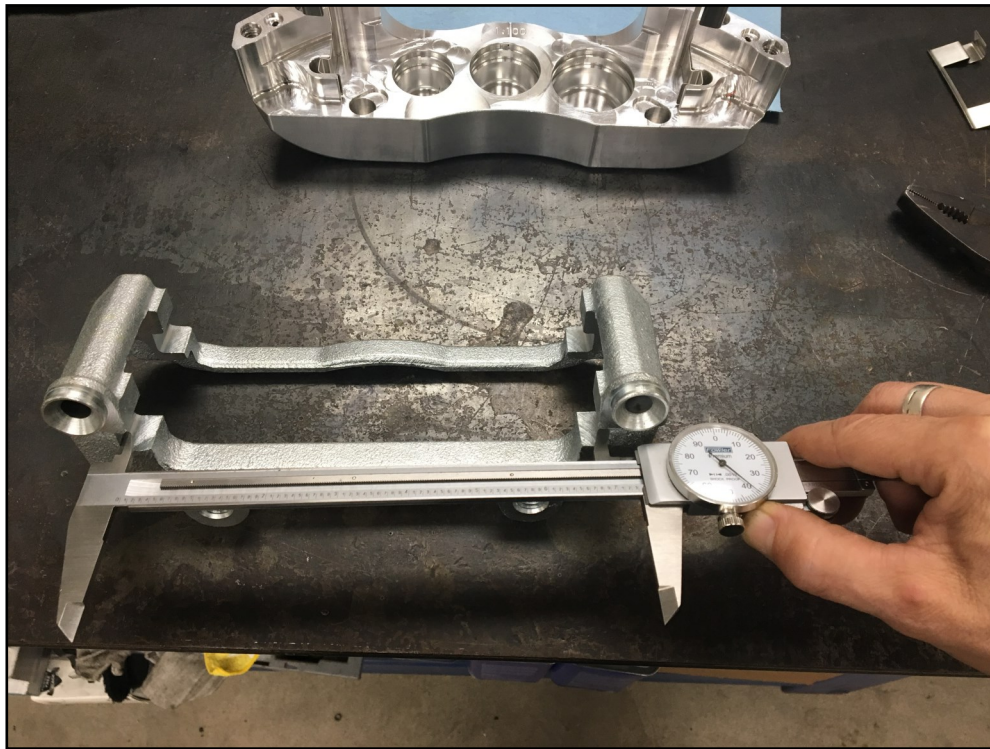
**Factory C5/C6 anchor**

The C5/6 abutment opening 7.340"

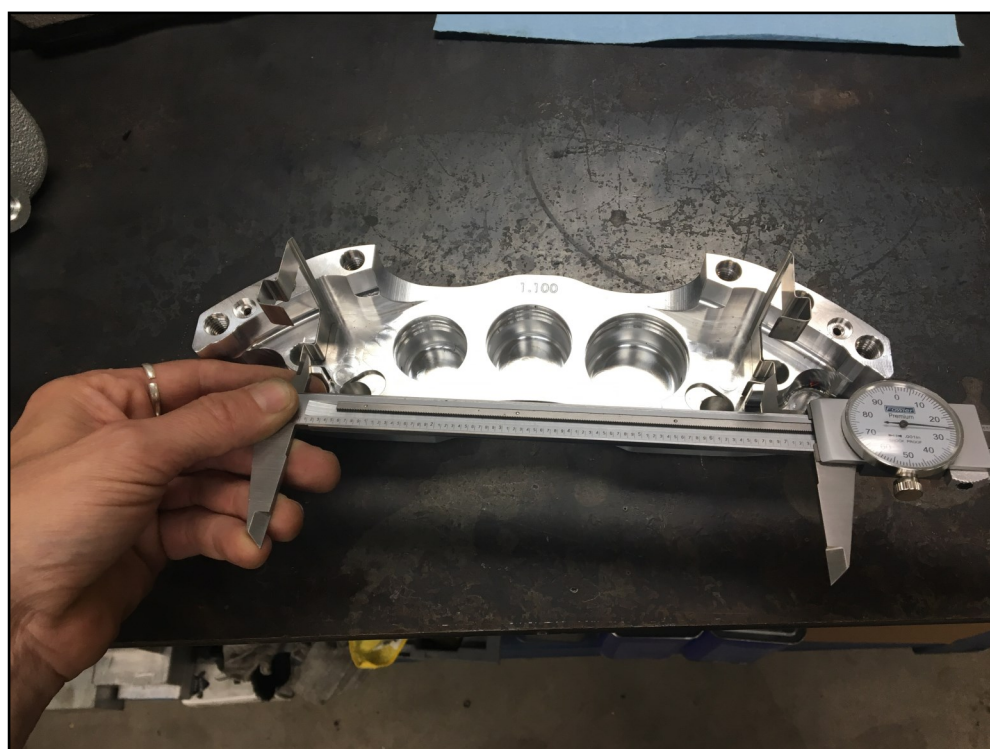
**Baer 6P caliper half**

**Findings:** Our abutments are modeled after the C5/C6 abutments and our caliper (abutment area) is modeled after the C5/C6 anchor (abutment area). Upon inspection I found our caliper opening to actually be .015" narrower.

The Baer 6p abutment opening 7.325"

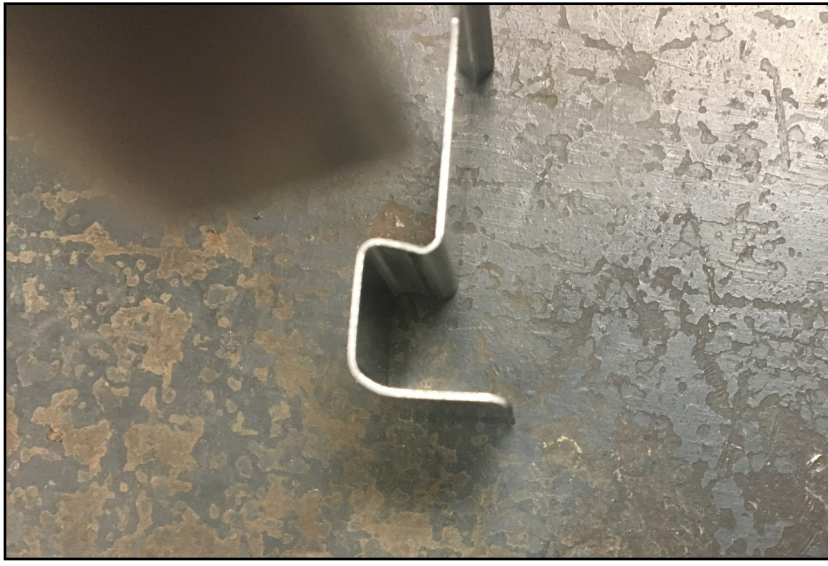
**before bend**

**Solution:** Using a small pliers, we can put a slight bend (Which will act like a spring) in the bottom of the abutment. This will hold a bit of tension on the bottom of the pad.

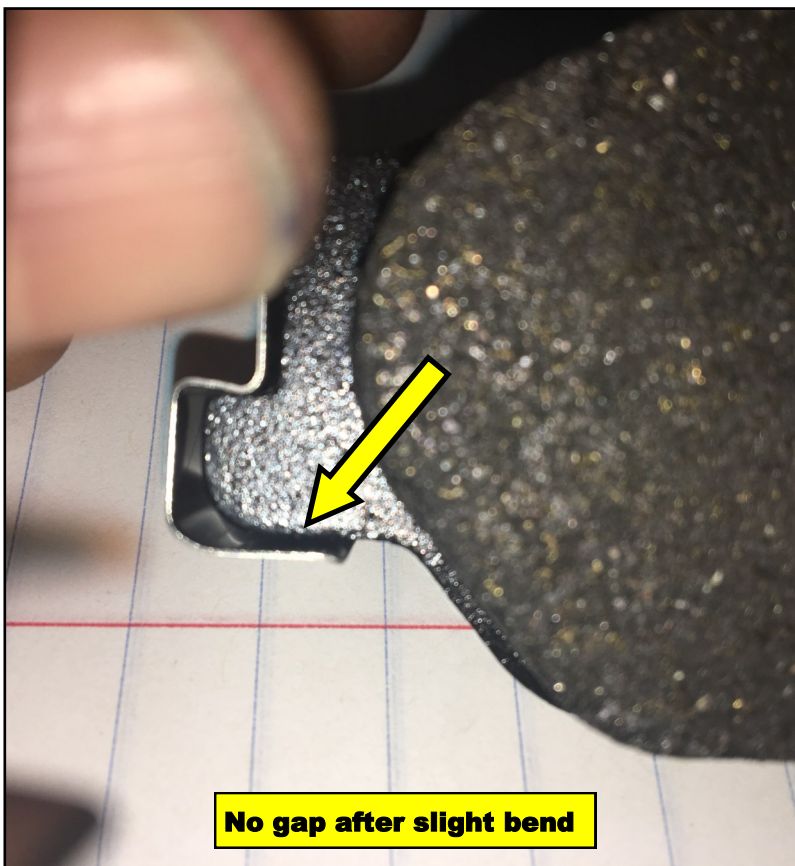
**No gap after slight bend**
