BMW E9x/E36/E46/E39/F3x/F2x Poly Rear Shifter Bushing Installation

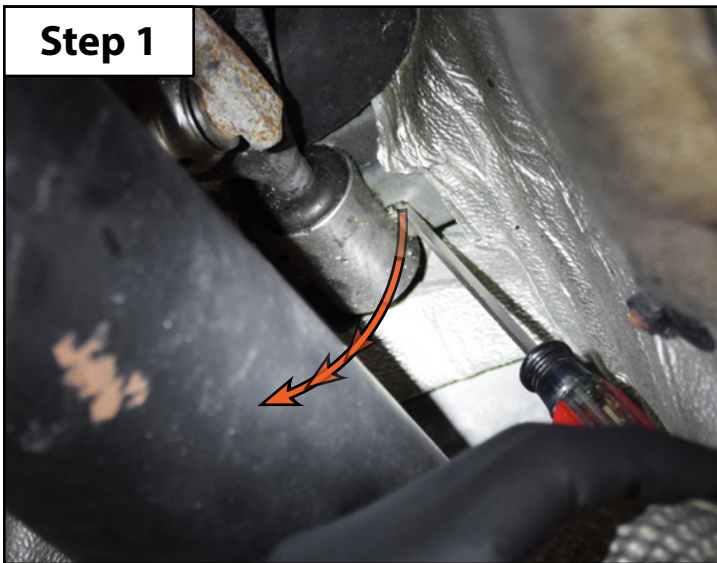
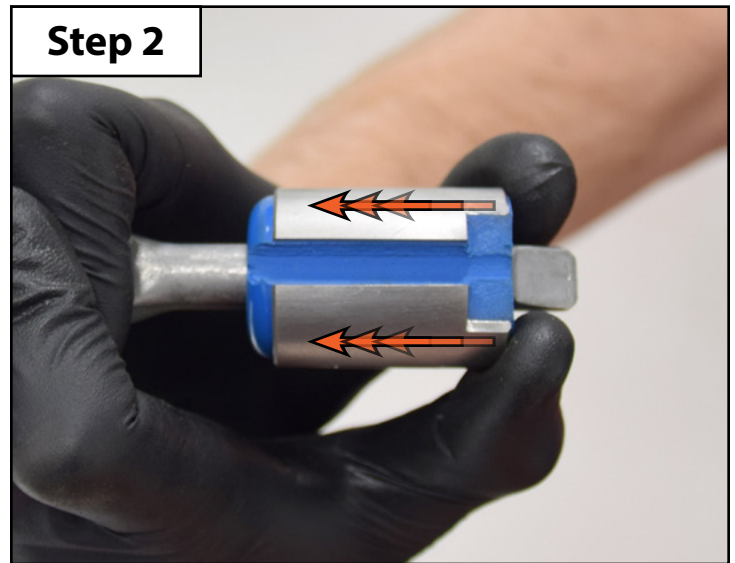
- Step 2**
- Pull the stock bushing off of the shifter arm, then slide the new polyurethane bushing on in its place. Ensure that the cut-out relief channel is facing upward towards the vehicle as shown in the step 2 photo below.

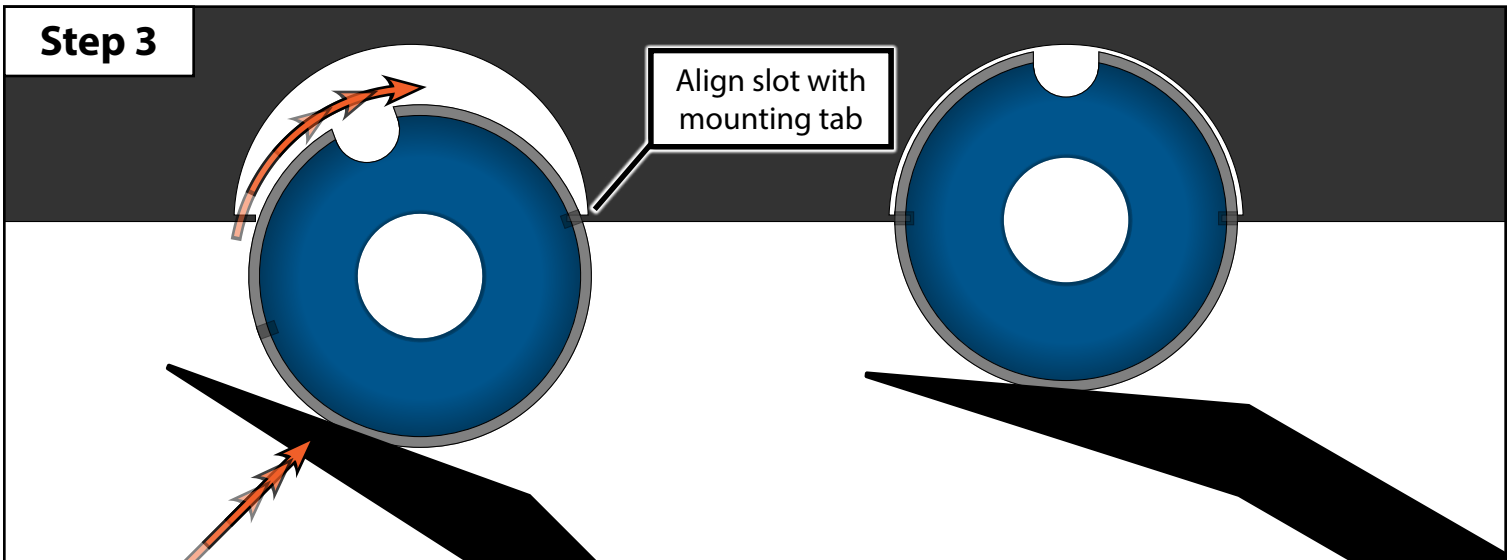
- Step 3**
- Align one of the slots in the bushing sleeve with its matching mounting tab on the chassis (with the relief channel facing upwards).
 - Using a prybar for leverage, push upward on the bushing and roll it into alignment with the other mounting tab. This is illustrated in the step 3 diagram below.

- We have found that using the driveshaft as a fulcrum for leverage is the easiest and most effective method for getting these bushings installed, but be sure to put a small piece of wood between the driveshaft and prybar to prevent damage. The new poly bushing is much stiffer than the stock rubber bushing, so it may require some elbow grease in order to get it into position.
