Thank you for purchasing the new 2.0T TSI Manifold Lever Arm Fix Kit from ECS Tuning, we appreciate your business!

Project Overview:

The lever arm of the intake manifold runner flaps has a tendency to fail and separate from the shaft, causing an intake runner malfunction as well as boost leaks. This may cause a check engine light as well as drastically reduced performance. Until now, the only solution to this issue was to replace the entire intake manifold assembly which is both costly, and time consuming.

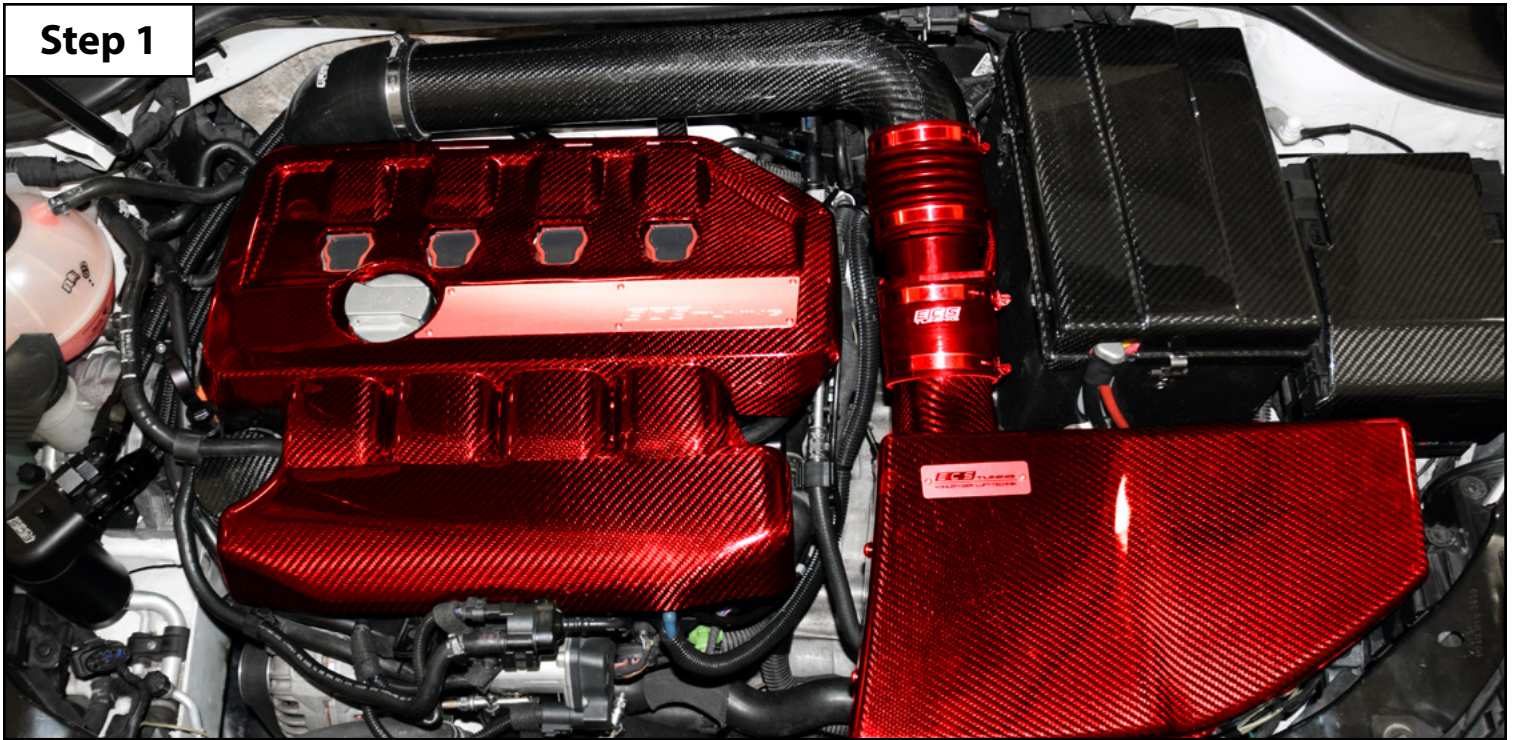
Step 1

- Step 1**
- In order to access the stock lever arm housing, you must first remove the engine cover and the air intake (highlighted in the photo below in red.)
- Step 2**
- Locate the stock plastic lever arm housing on the LH side of the intake manifold behind the runner flap vacuum actuator as shown in the photo below.
 - The new fix cap will install directly over this housing.

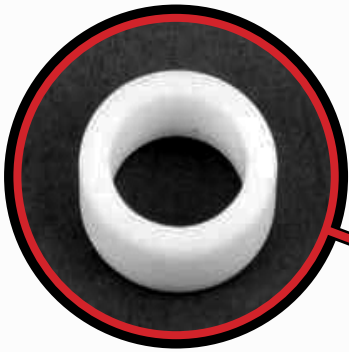
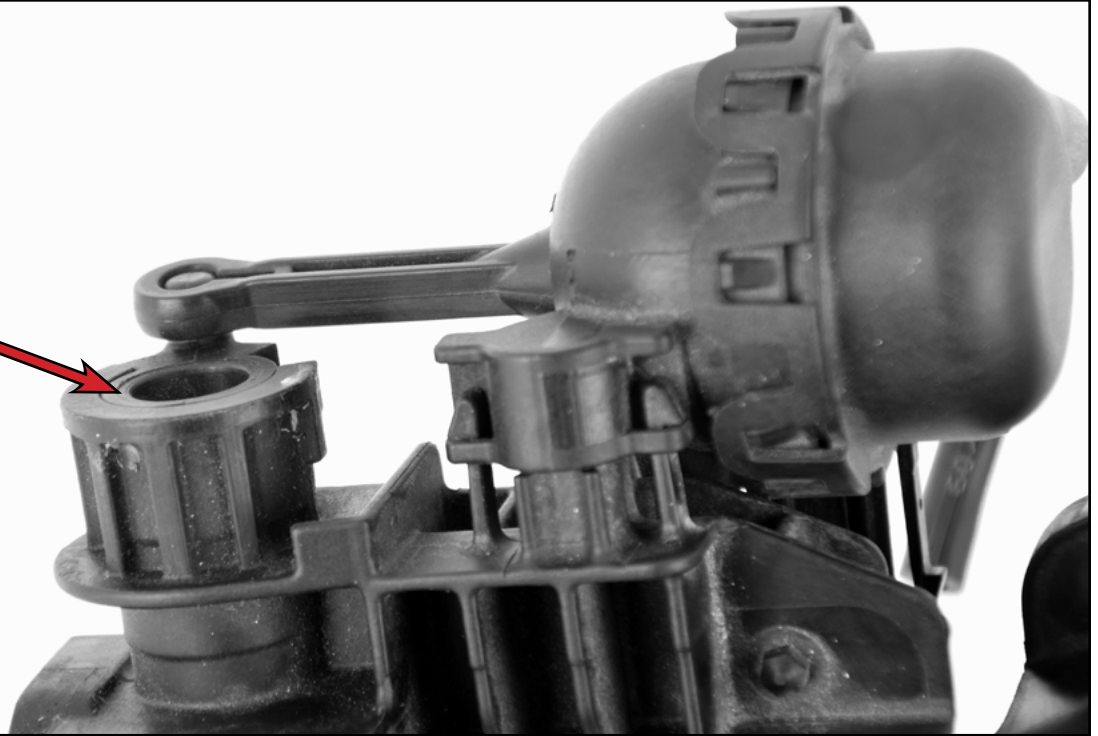
Early Manifolds

- Step 1**
- Your new intake manifold lever arm fix kit will include two different thickness Teflon™ spacers, but only one of them will be used during the installation. The intake manifolds have been through several revisions over the years, so you will need to identify which style of manifold your engine is equipped with.
 - Early production intake manifolds feature a lever arm which sits flush with the housing, this style requires the thicker Teflon™ spacer.
 - Late production manifolds feature a lever arm which protrudes from the housing, this style requires the thinner Teflon™ spacer.

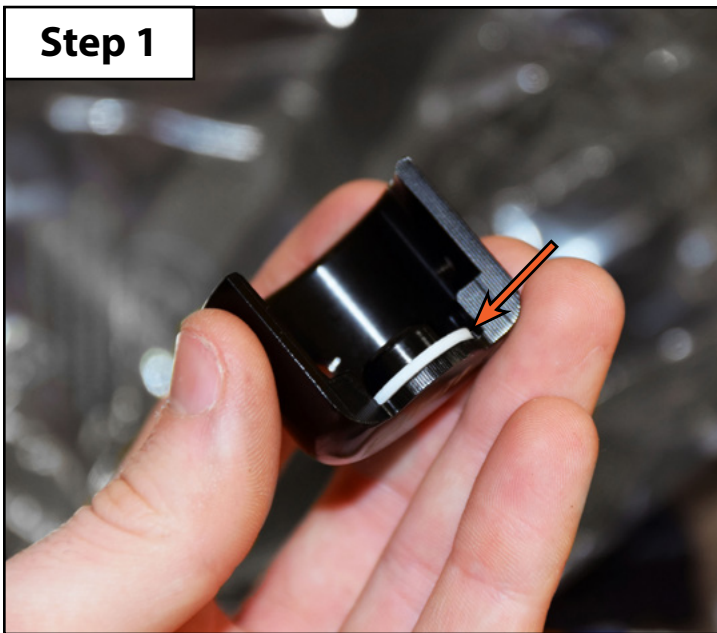
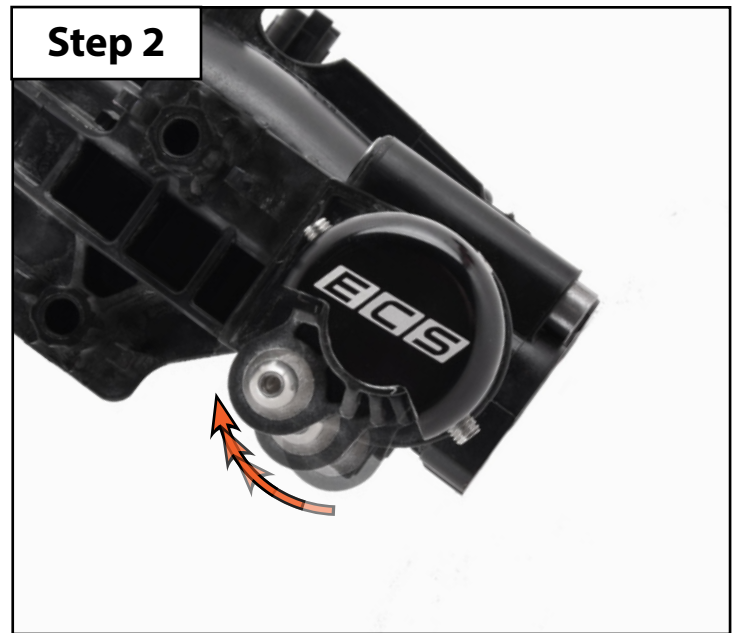
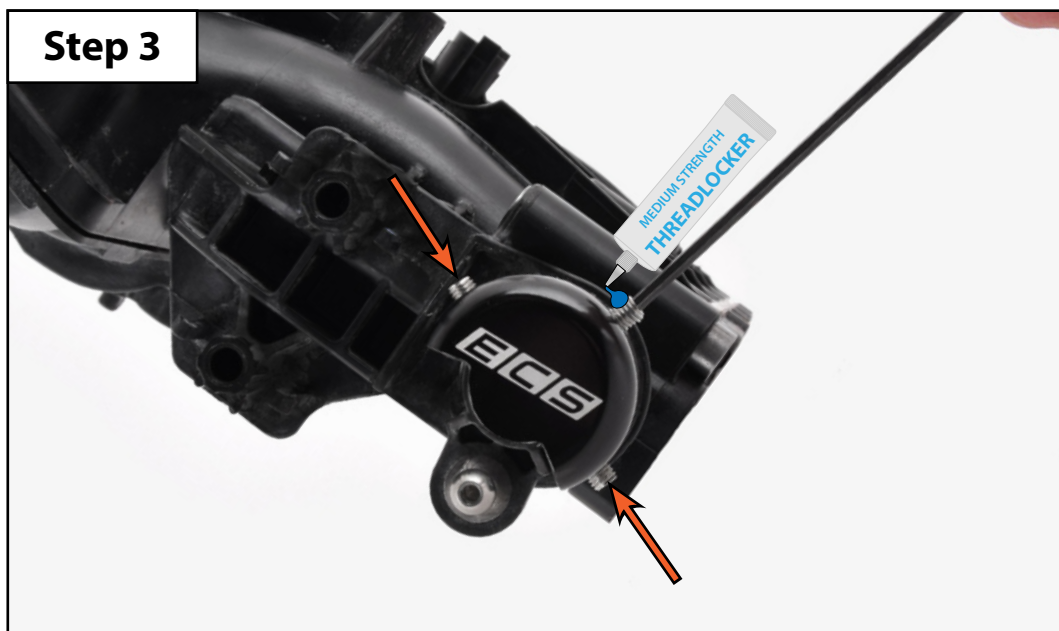
- Step 1**
- Choose the appropriate Teflon™ spacer and place it into the fix cap as shown in the photo below.
 - This will hold the lever arm into place, maintaining the seal while still allowing the arm to rotate freely.
- Step 2**
- Place the fix cap over the lever arm housing, with the cut out portion positioned to allow the lever arm to rotate freely.
 - Note that the actuator rod is not shown in the installation photo below.
- Step 3**
- Apply a single drop of the provided blue threadlocker to the screws to prevent them from loosening over time.
 - Tighten the three screws using the provided allen key as shown in the photo below.
 - Tighten the screws only until contact is made. **DO NOT OVERTIGHTEN.**
 - When installing the screws on the vehicle space will be very limited, you might only be able to turn the screws ¼ turn at a time until they are properly tightened.

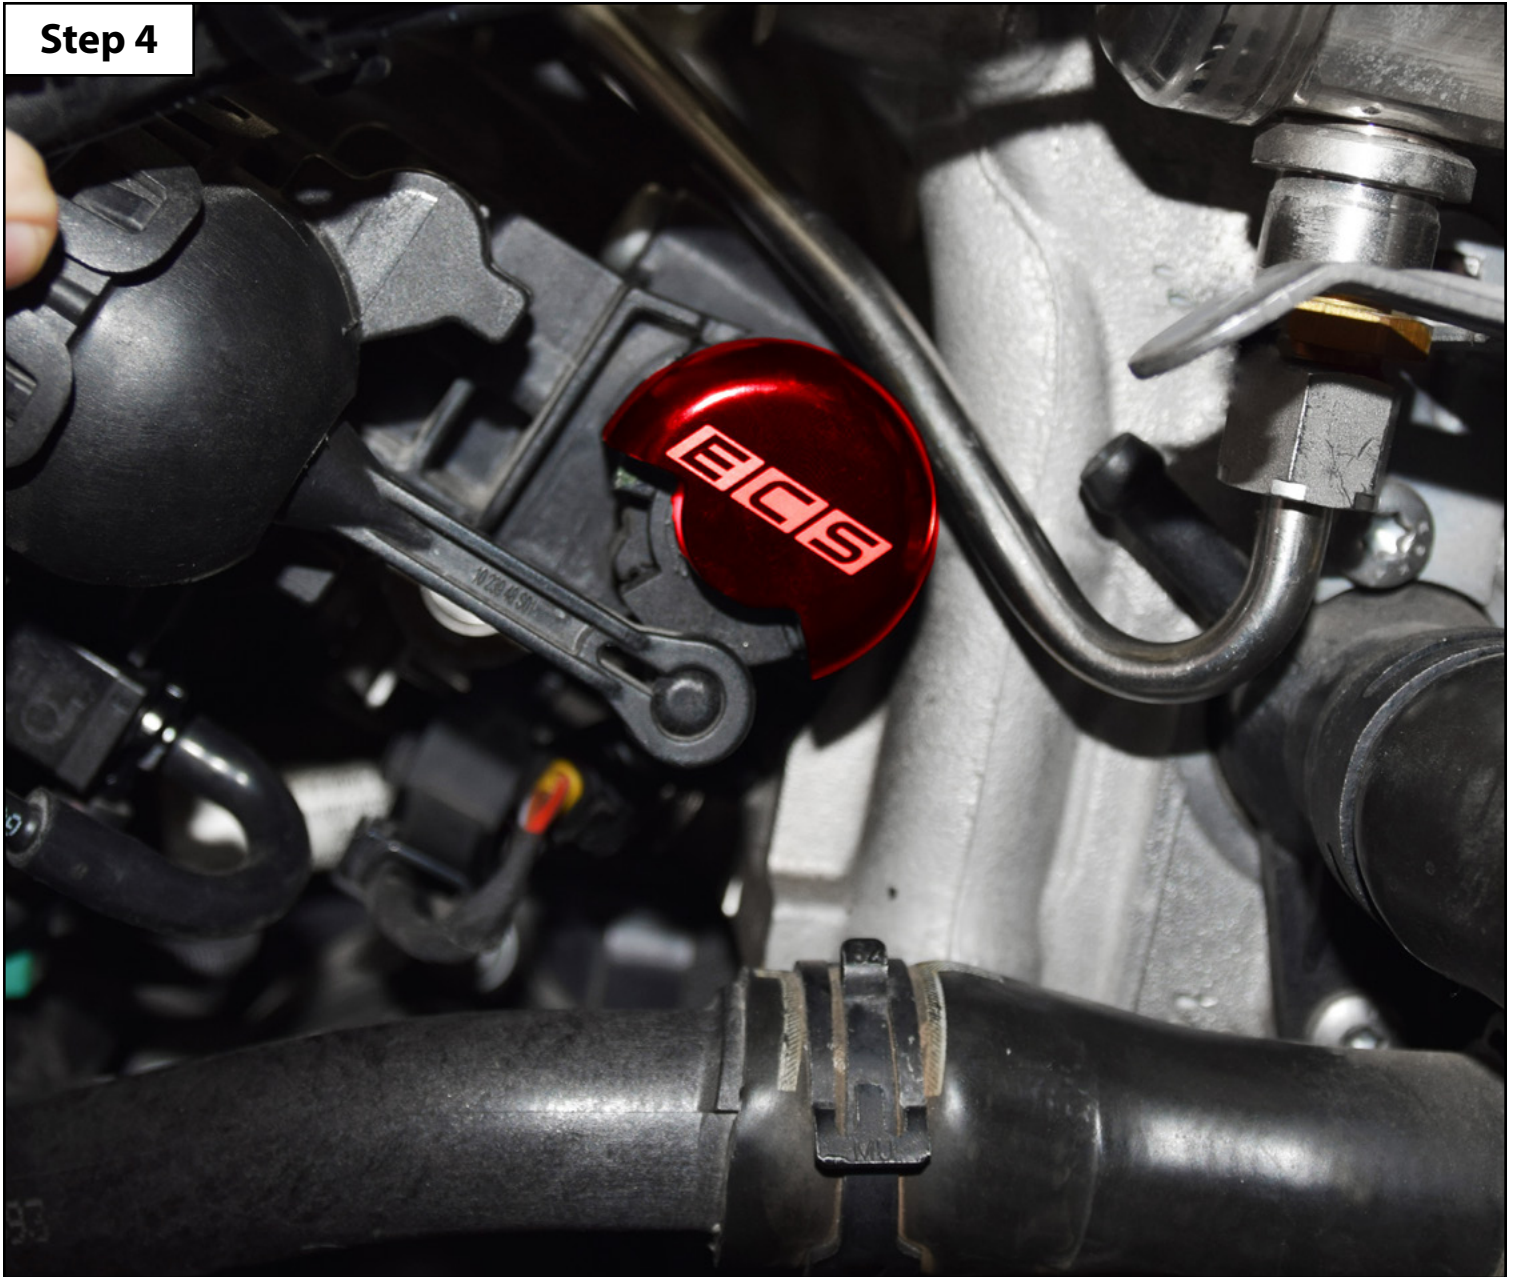
Step 4

- Before reinstalling the engine cover and air intake, ensure that the fix cap is properly secured and oriented as seen in the photo below (highlighted in red.)
- Reinstall the engine cover and the air intake.
