**Technical Investigation:** 6P & T4 abutment check with aftermarket D0731 pads.

11 June 2019

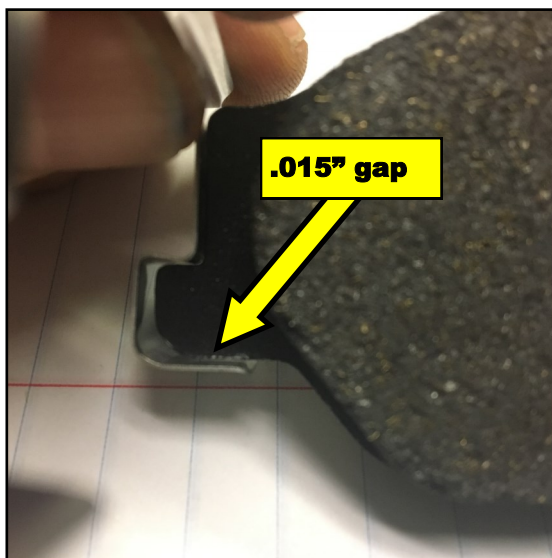
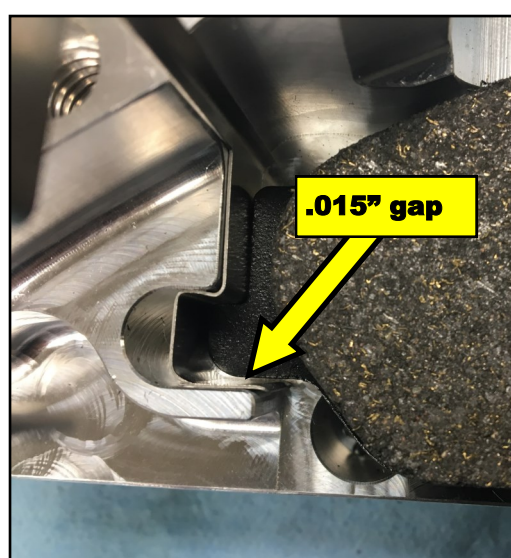
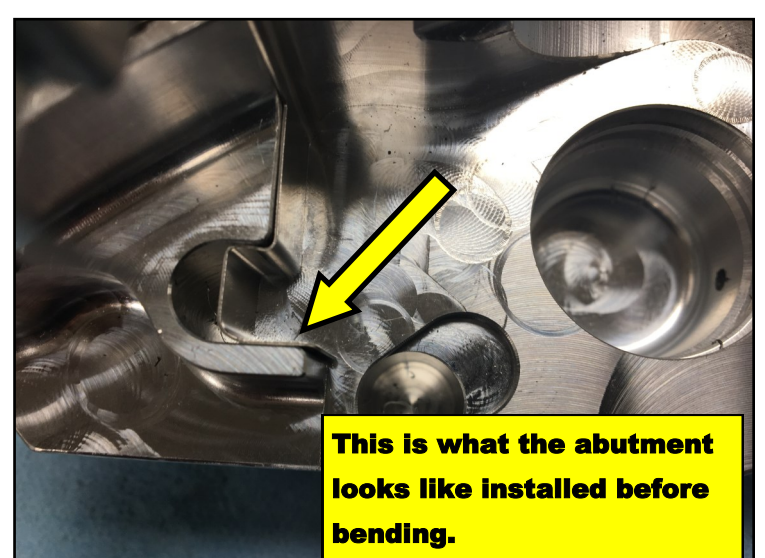
**Findings:** Our abutments are modeled after the C5/C6 abutments and our caliper (abutment area) is modeled after the C5/C6 anchor (abutment area). Upon inspection I found our caliper opening to actually be .015" narrower.

- Both our abutment and the factory C5/6 abutments measure .015" thick.
- The aftermarket backing plates can vary a good amount. The D0731 Ferodo pad seems to be a bit more loose in our abutments than our standard pad. The issue seems to be once installed (and driven on) the pad can slightly move top to bottom.

**Solution:** Using a small pliers, we can put a slight bend (Which will act like a spring) in the bottom of the abutment. This will hold a bit of tension on the bottom of the pad.
