Installation Procedures

Part Numbers: ES250690
ES6065
VW Golf/Jetta
MKV and MKVI 2.0T
Noise Pipe Bypass Duct
Installation

This tutorial demonstrates how to remove the **noise pipe** from your Golf V 2.0T.

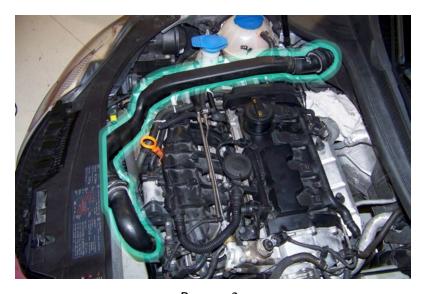
- Remove the old noise pipe (silhouetted in image below).
- Install a revised air duct between the intercooler outlet and throttle body.
- Install a blocking plate in the cowl area water tray to keep vermin from making nests (and chowing down on your wiring harness!).

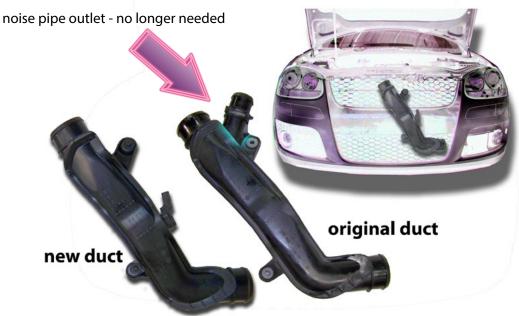
Step 5.

Next, we need to replace the original air duct between the intercooler outlet and throttle body. The original duct has an extra outlet for the noise pipe (arrow). We will replace it with a new duct that has no noise pipe outlet.

For reference: The duct is located on the front of the engine, just behind the electric cooling fans, as shown in out image.

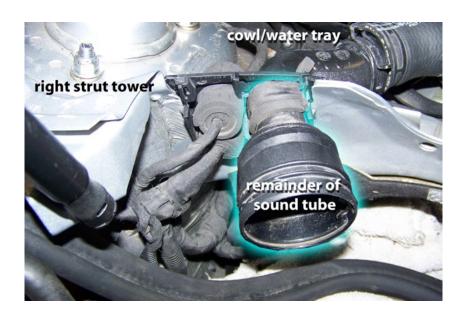
Step 11.

Now we need to remove the rest of the noise pipe from the water tray and block off the hole it leaves.

- Remove the top locking clip that retains the sound tube and wiring harnesses (arrow).
- Remove the sound tube from the water tray. (Already removed here. See image Step 11 to see tube installed.)
- Wiggle the lower plastic retainer around the wire harnesses and remove it from the water tray.

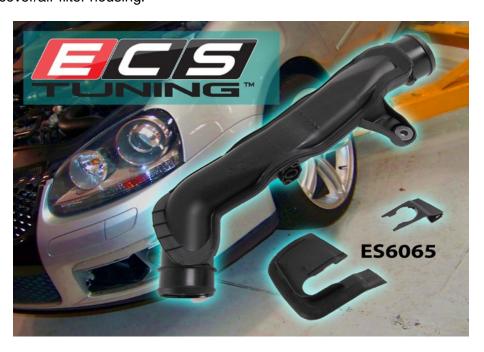
Old and new air ducts, side by side.
